The Performance of Turlough Hill Upper Reservoir

THE PERFORMANCE OF TURLOUGH HILL UPPER RESERVOIR

Paper No. 2.20

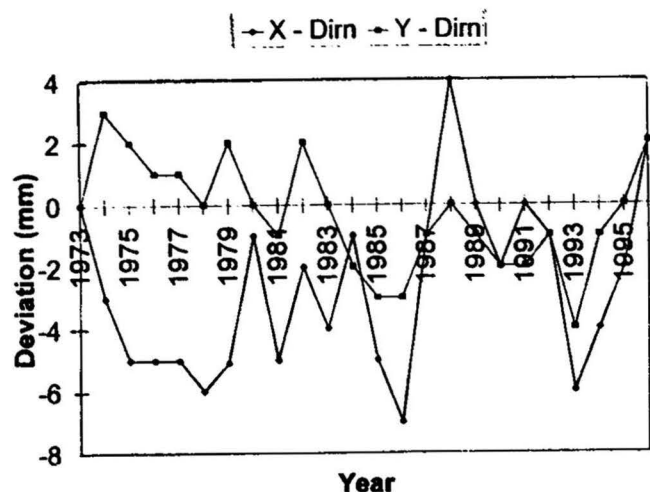
Fig. 5 Results of triangulation surveying C/S 7

A typical result of the triangulation surveys for Cross Section 7 on the western side of the embankment is shown on Figure 5. The readings are given in terms of deviation from the original reading in 1973. It can be seen that the movements measured are negligible and are within the accuracy of the surveying equipment.

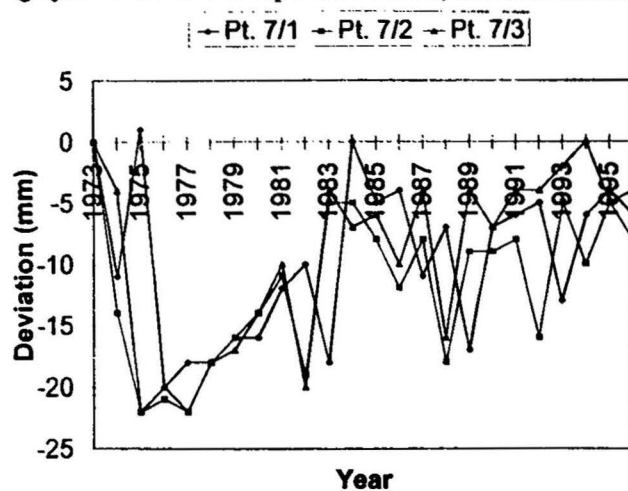
Fig. 6 Crest Leveling survey

The results of crest leveling for three points (7/1 to 7/3) on the southern side of the embankment are shown on Figure 6. The readings are given in terms of the deviation from the original reading in 1973. The trend is an initial settlement of some 20mm over the first 3 years followed by a gradual heave of the crest. These movement are possibly due to thermal effects and are of no significant consequence.

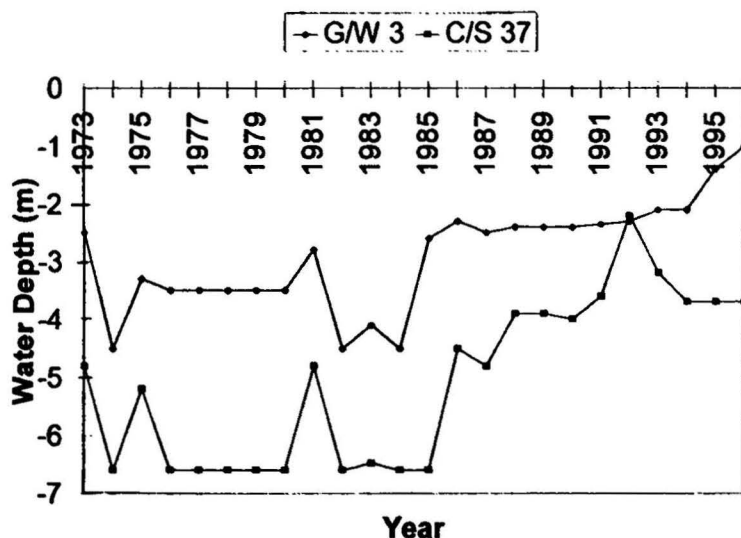
Fig. 7 Water level soundings

Water level sounding readings are taken from 9 boreholes located on the outside toe of the embankment and from 5 points at the base of the ring drainage gallery. The results of monitoring of Gallery Well 3 and the adjacent outer well at Cross Section 37 are shown on Figure 7. The readings follow a similar trend with an initial fall in level followed by a gradual rise since 1984. The increase in head outside the embankment has been greater than that inside the gallery. This same pattern is repeated elsewhere and may indicate a trend for external groundwater to flow into the ring drainage gallery.

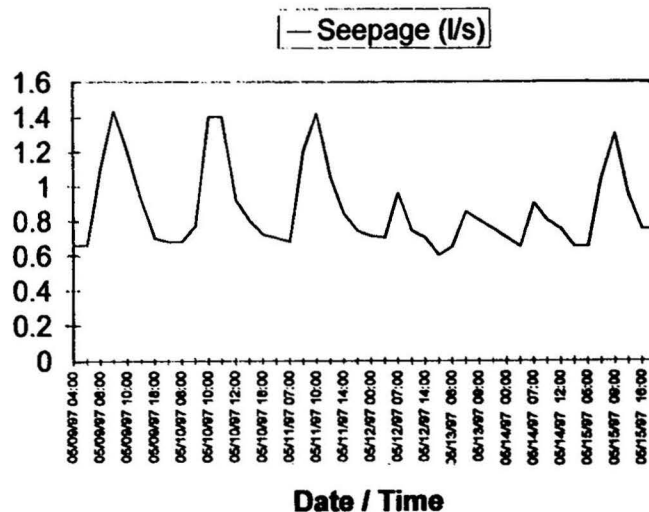
Fig. 8 Total seepage w/c 9th. May 1997

A typical record of seepage rate for a week in May 1997 is shown on Figure 8. The pattern shows peak seepage early in the morning with the seepage reducing during the day. This corresponds directly with reservoir water level, which is at its highest in the early morning, following overnight low cost pumping from the lower reservoir, and which falls during the day as electricity is generated.

Experience shows that seepage increases if the reservoir is maintained at a high level for prolonged periods, e.g. holiday weekends. There is roughly a 4 hour lag between maximum reservoir level being attained and peak seepage. Seepage appears to be independent of climatic or seasonal effects, suggesting that the contribution from the external groundwater is very small.

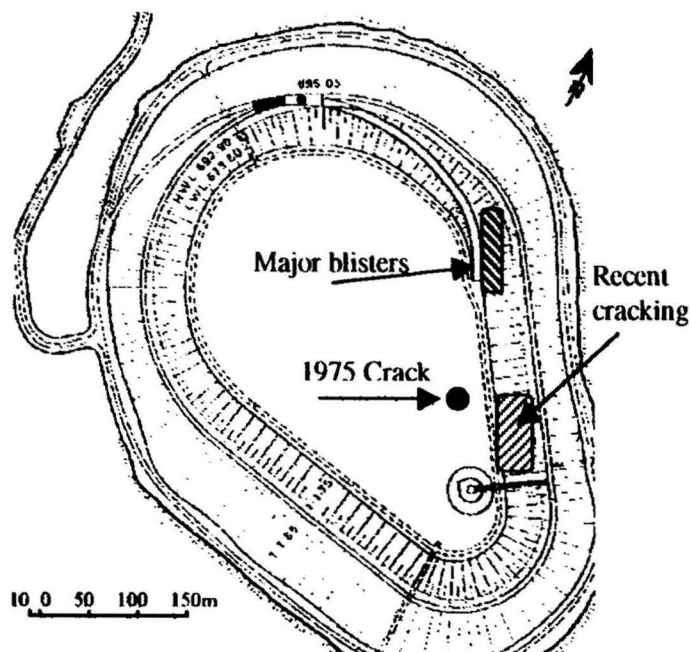
Fig. 9 Location of seepage / defects

The seepage is mostly from a series of pipes on the eastern side of the reservoir, as shown on Figure 9, from the pipes located on the outside face of the drainage gallery, suggesting that the seepage originates from the sides of the reservoir.

The most significant defect in the lining system was a 10mm wide 4m long discontinuous crack which was discovered and repaired in 1975. The location of this crack is shown on Figure 9. This crack caused the high early seepages discussed in the previous section. No reason for the crack was discovered. It was repaired by removing the defective lining material to the drainage layer and replacing it by 3 layers of wearing course asphalt.

Minute seepage of water into the junction between the binder and dense layer has resulted in hydrostatic pressure causing 100mm to 500mm blisters in the dense layer. About 10 of these blisters have occurred at the location shown on Figure 9. The source of the water which caused the pressure is not clear. These blisters never resulted in any reservoir seepage. Having attempted various repair methods, the following method has been used successfully on all the blisters.

Along the eastern side of the reservoir, on the upper exposed part of the lining, several cracks some 3mm wide and up to 4m long can presently be observed, see Figure 9. An opportunity for detailed inspection and perhaps correction will be afforded by an empty reservoir in July 1997.

- chisel a neat (16mm dia.) hole to the drainage layer,
- drive a hard wood plug into the dense layer leaving 40mm for an asphalt plug at the surface,
- fill with heated asphalt,
- place a flat stone on surface and cover with asphalt.

Any water present can seep to the drainage layer via the hole.
